# Manhole Inspection Summary

Manhole # S51QQ\_010MH

Insp Date: **6/16/08 11:34 AM**

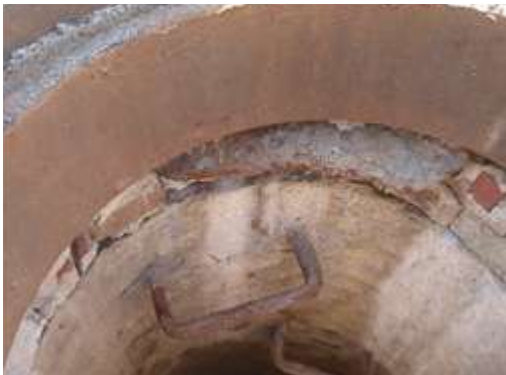
Defect 1

Condition: ☐ Sound ☐ Cracked ☐ Root Intrusion ☒ **Loose Brick** ☐ Deteriorated

Infiltration: ☐ None ☐ Joint ☐ Cracks ☒ **Mortar** ☐ Roots ☐ Wall

Loose bricks

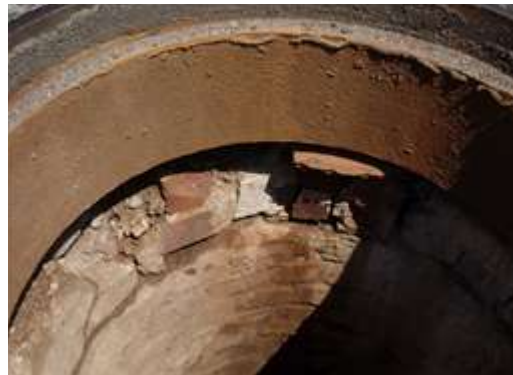
Defect 2

**Frame** Offset: **2** (in.) Condition: ☐ Sound ☐ Cracked ☒ **Leaks**

Frame leaks

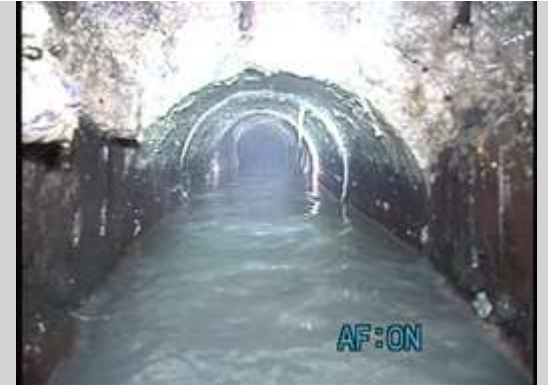
12 O'Clock Outflow

12 in. Circular Gravity Sewer  
Pipe Out @ 12 O'Clock

Pipe Height: **12** (in.) Rod and Bar (Angled)  
Pipe Material: **Clay** ☐ Pipe Lined  
Invert Depth: **14.90** (ft.) Flow Characteristics: **Fast**  
Deposits: ☒ None ☐ Mud ☐ Sludge ☐ Debris ☐ Grease  
Silt Depth: (in.) Deposits Extent:  
Infiltration: **None** Pipe Seal Cond: **Sound**

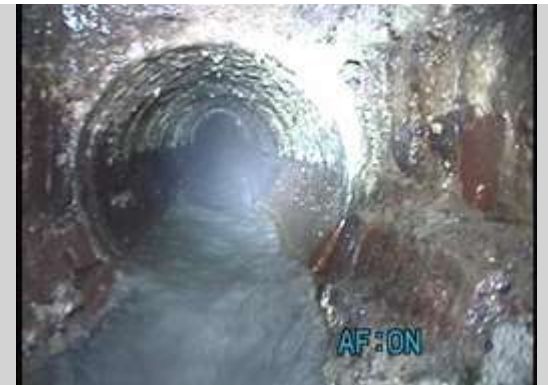
6 O'Clock Inflow

12 in. Circular Gravity Sewer  
Pipe In @ 6 O'Clock

Pipe Height: **12** (in.) Rod and Bar (Angled)  
Pipe Material: **Clay** ☐ Pipe Lined  
Invert Depth: **14.70** (ft.) Flow Characteristics: **Fast**  
Deposits: ☒ None ☐ Mud ☐ Sludge ☐ Debris ☐ Grease  
Silt Depth: (in.) Deposits Extent:  
Infiltration: **None** Pipe Seal Cond: **Sound**
